Final Report

Triggered Lightning Testing of a Section of Florida Gas Transmission Pipeline and Pipeline Connectors

Report on Triggered Lightning Testing of a Section of Florida Gas Transmission Pipeline and Pipeline Connectors

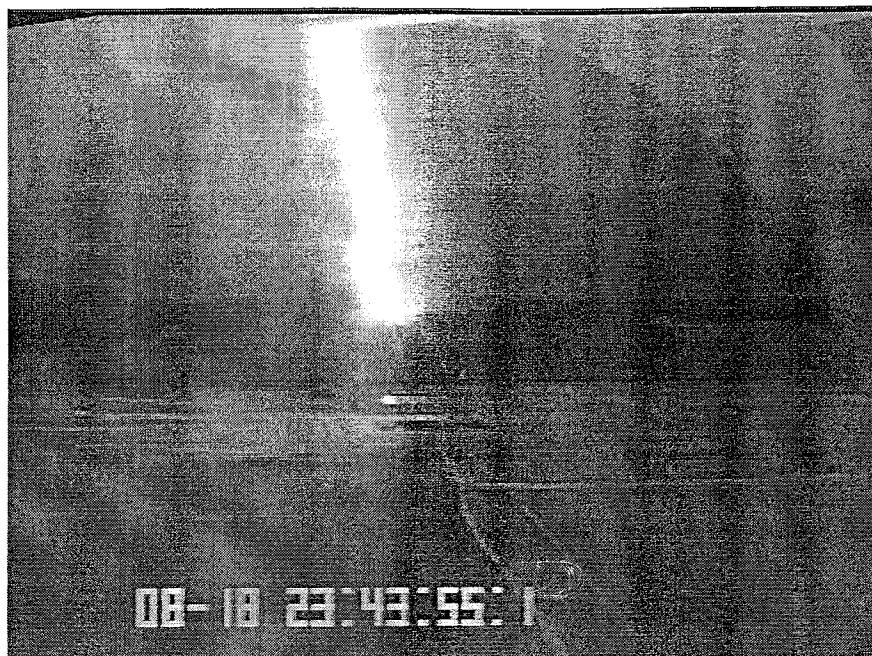
A photograph of a triggered lightning flash to the pipeline is shown in Figure 5. Current records show that five return strokes attached to the pipeline. High speed photography confirms that each return stroke attached to the top of the pipeline, and thus that current flowed through each insulating joint. The current waveform of the first stroke is found in Figure 6, measured by a resistive shunt at the base of the pipeline. An external flashover at the Pikotek joint is evident in the TV frame shown in Figure 5 and in other photographs of the experiment. Comparison of current and photographic records shows that the external flashover occurred during the first return stroke which attached to the pipeline (peak current ≈ 27 kA). After the lightning strike, the pipeline joints were tested electrically and all were found to be still essentially open circuits. A small arc mark was evident on a bolt of the Pikotek joint, as shown in Figure 7, consistent with the external flashover seen in Figure 5. High-speed photography with 5 msec resolution indicates that the external flashover occurred for only the first stroke of the five-stroke flash. The joints were disassembled to inspect for internal damage. All joints show significant internal arc damage. Photographs of that damage are shown in

Fig. 5. Triggered lightning flash to the pipeline. Note the flashover at the lowest joint, the Pikotek joint.

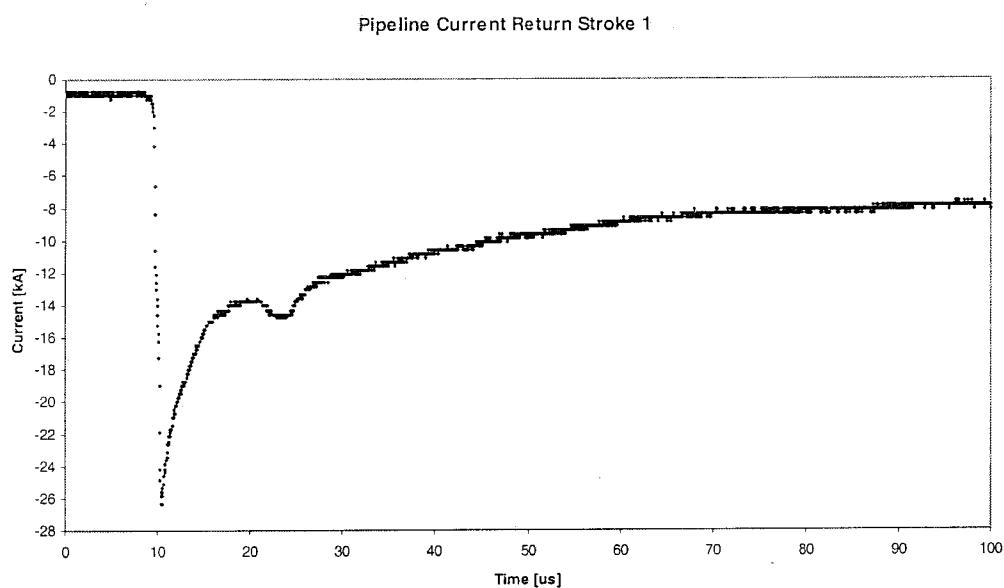
Fig. 6. Current waveform for the first of five return strokes, the only one that produced an external flashover.

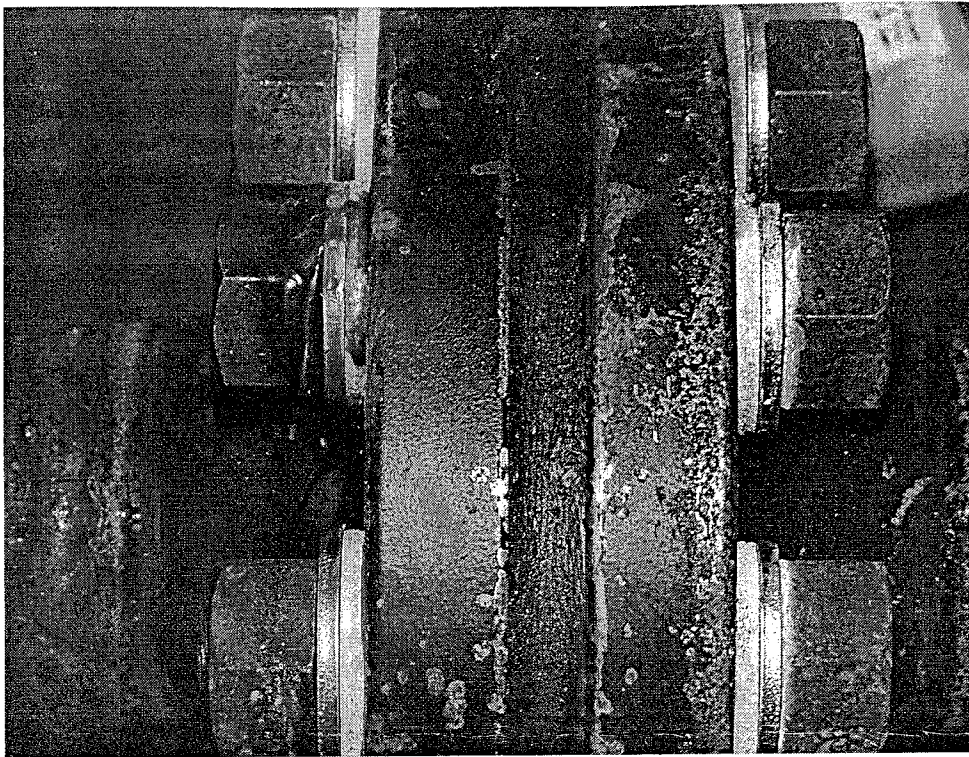
Fig. 7. Arc marks on the exterior of the Pikotek joint. In the photograph the marks appear as mottled silvery surfaces on the washers of the middle bolt on the left of the flange. Photo courtesy of Martin Winger.

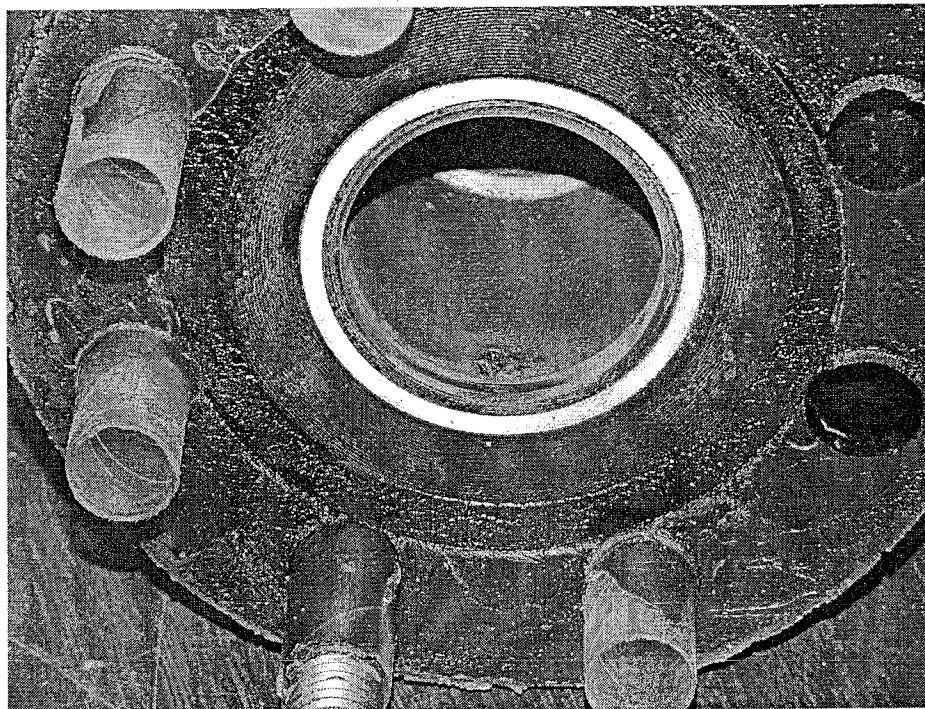
Figures 8 - 10. Visually there is not serious damage to the joint insulators, only dark surface tracks, although clearly very large currents and charges arced internally from pipe to pipe across the insulators.

Fig. 8. Arc damage on the interior pipeline surface on one side of the Pikotek joint. Photo courtesy of Martin Winger.

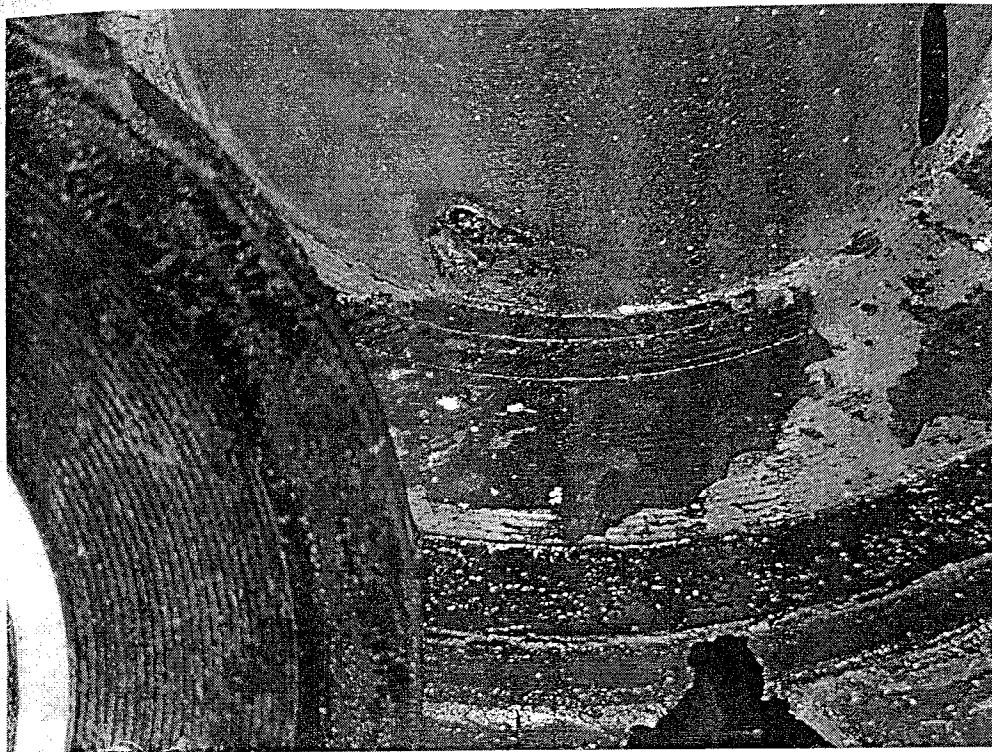
Fig. 9. A close-up view of the Pikotek joint shown in Fig. 8 with the insulating gasket removed. Photo courtesy of Martin Winger.

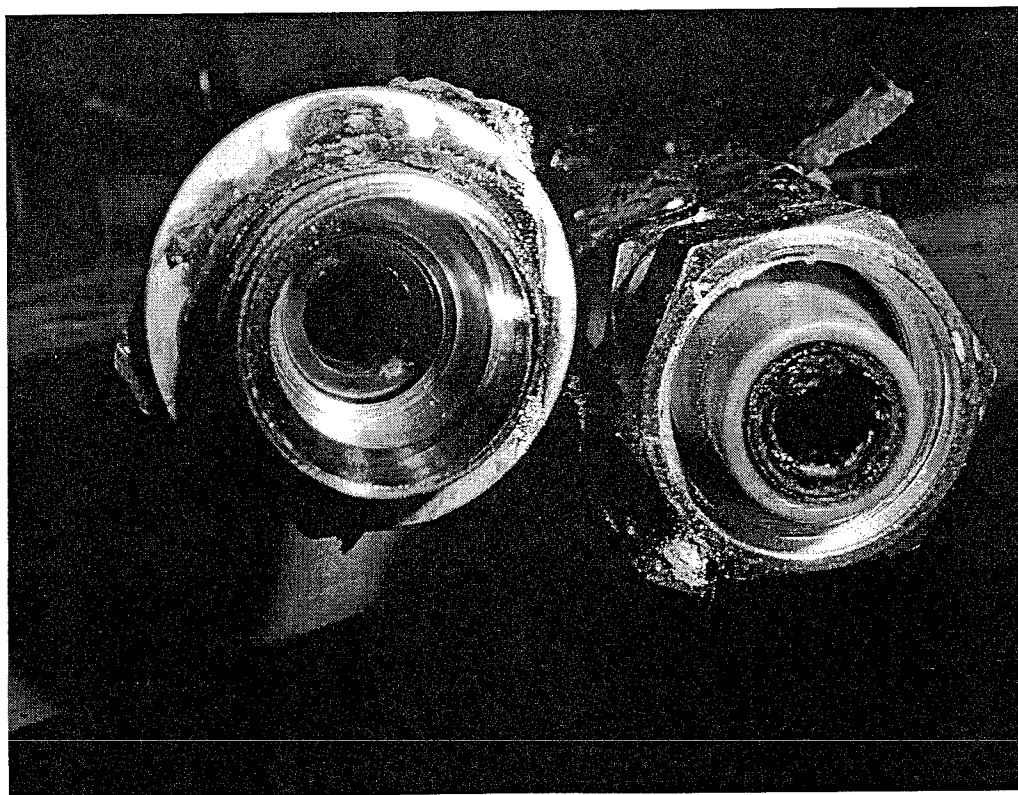
Fig. 10. Interior arc mark on one of the Swagelok joints evident on the lower right of the left pipe connector.
