# The Problem with GRE Gaskets and Steam

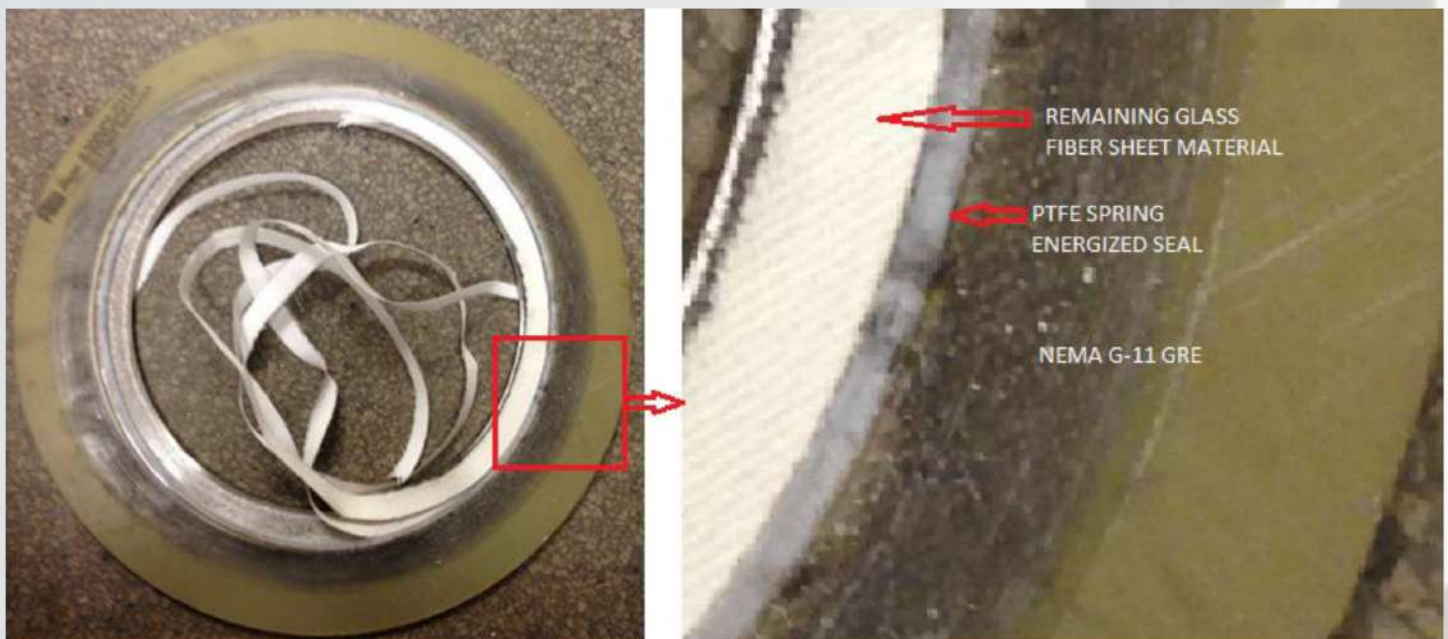
The problem with GRE when exposed to steam is a chemical degradation process, known as hydrolysis, which takes place with the epoxy resin. The word hydrolysis comes from Ancient Greek hydro-, meaning “water,” and lysis, meaning “to unbind.” A hydrolysis reaction is a “reaction involving an ester link, such as that found between two amino acids in a protein. The products that result include one that receives the hydroxyl (OH) group from the water molecule and another that becomes a carboxylic acid with the addition of the remaining proton (H+).”<sup>1</sup> In laymen’s terms, this means that the heated water molecules in steam chemically attack the ester links in the epoxy resin; therefore, eating away at the epoxy resin. This leaves only the glass fiber layers of the GRE sheet material behind. An example of this can be seen in figure 1.

*Figure 1: Shown is a GPT VCS™ gasket with SS316L core and NEMA G-11 GRE (green/yellow color) after being exposed to a steam based media for a few months. The glass fiber layers (white color) are all that remain between the PTFE seal (translucent white color) and the pipe bore/media after the epoxy was leached out during the chemical attack on the gasket. The gray color area is graphite residue from a previously installed spiral wound gasket in the flange assembly.*

It is important to recognize applications where elevated temperatures and the production of superheated water and/or steam are present to avoid the use of a gasket that would leave GRE exposed to the media. GPT has developed products such as the VCS-ID™ gasket and the new Evolution™ gasket to overcome the limitations of GRE in steam applications.

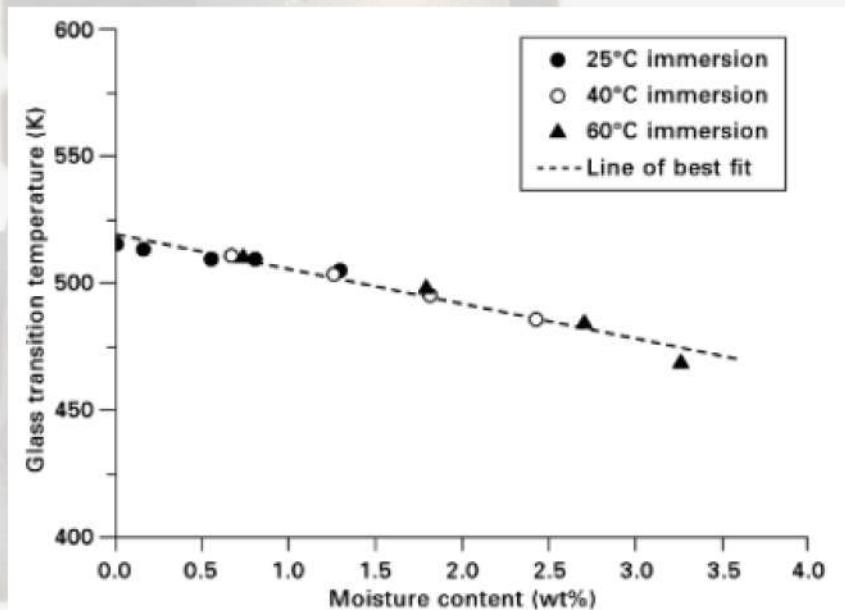
Figure 2 “shows the effect of moisture content on (glass transition temperature)  $T_g$  for a glass fibre-reinforced epoxy system that has been immersed in distilled deionized water for prolonged periods of time at three different temperatures.”<sup>3</sup>

Figure 2: Glass transition temperature  $T_g$  of an epoxy resin as a function of moisture content.<sup>3</sup>

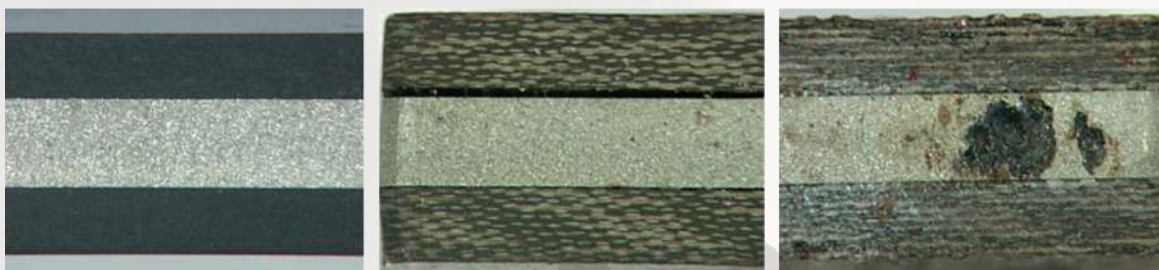
As temperature increases, the epoxy resin begins to leach out of the glass fiber sheet material. The process of hydrolysis and leaching can occur as low as 60C (140F) and it may take months to even a few years for the material to be fully saturated by the slow moisture absorption rate.<sup>3</sup> This process begins to occur quicker as temperature and exposure time are increased. For applications involving steam, which typically involve higher operating temperatures, failure of a GRE based gasket can occur in as little as a few months into operation. The results of exposure to steam are seen in the images of figures 4 and 5. Measurements of these samples are shown in table 1. As the epoxy leaches out of the glass fiber layers, the GRE laminate material begins to disbond from the SS316L core.

Figure 3: A cross section of new  $VCST^M$  material with SS316L core and NEMA G-10 laminated GRE on the top and bottom sides of the core (left). The cross section of the G-10 sample after submersion in heated water at 350F under 120 psig pressure for 168 hours (center). The cross section of the G-10 sample after exposure to steam at 350F for 168 hours (right).<sup>4</sup>

*Table 1: Hardness and thickness measurement results of the G-10 and G-11 samples from figures 3 and 4 before and after being exposed to steam. The samples expand and experience a loss in hardness and tensile strength.<sup>4</sup>*

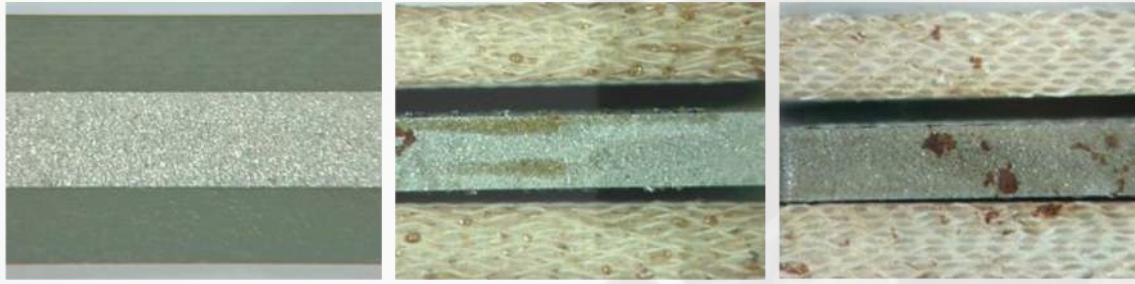
*Figure 4: A cross section of new VCS™ material with SS316L core and NEMA G-11 laminated GRE on the top and bottom sides of the core (left). The cross section of the G-11 sample after submersion in heated water at 350F under 120 psig pressure for 168 hours (center). The cross section of the G-11 sample after exposure to steam at 350F for 168 hours (right).<sup>4</sup>*
