A different kind of animal

Tim Hurley, GPT Industries, USA, explains the differences between a standard gasket and an isolation kit, and the importance of properly installing them.

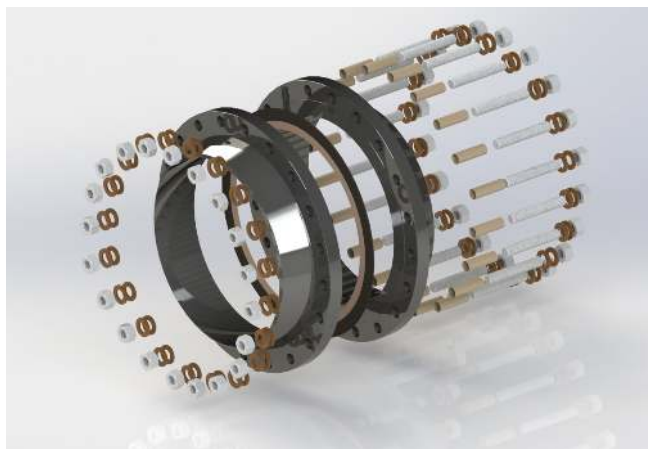
Figure 1. 24 in./600# flange = 193 individual components.

Up until this point, no isolation kit installation classes have existed. This is of importance because there are a large number of differences between installing a standard gasket and an isolation kit. If a field crew was asked to install a standard 24 in./600# gasket, the task is relatively straightforward as it is simply a gasket that will be installed. However, if a field crew was asked to install a 24 in./600# isolation kit, they are being asked to handle 193 pieces of equipment just to install that one kit (Figure 1).

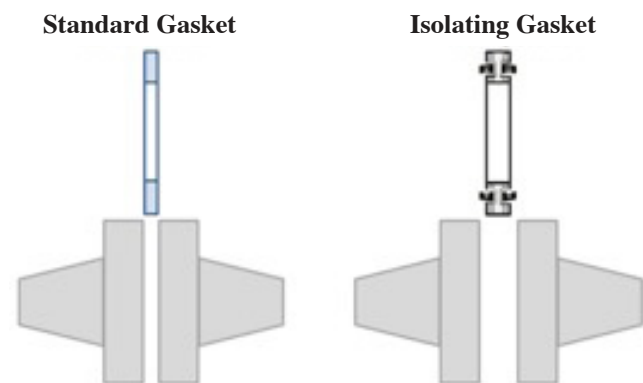
Figure 2. Left: 0.125 in. minimum flange gap. Right: 0.300 in. or 0.358 in. minimum flange gap.

three times thicker than this, it means the flange must be opened up with a gap at least equal to that width. This can be a challenging feat. Add to that the seal protrusion – most isolation gaskets have seals that protrude above the retainer surface by approximately 0.025 in. on each side of the gasket – and this means a flange must be opened up at least 0.300 in. to 0.358 in. to install the gasket without contact to the flange face, whereas a standard gasket only needs to have a flange opened at least 0.125 in. (Figure 2).

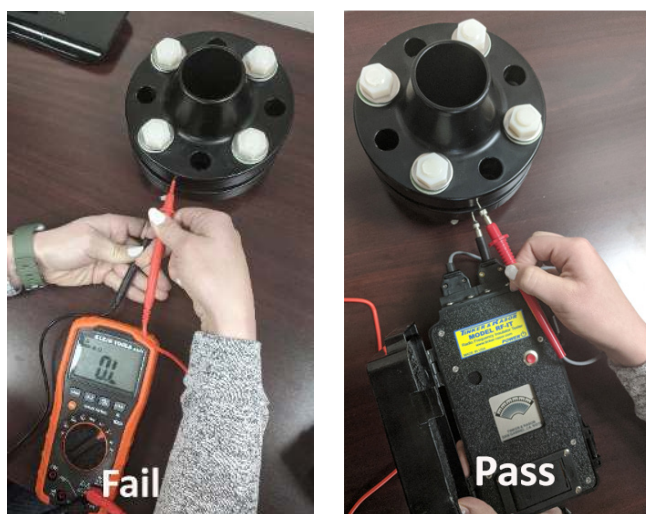
Figure 3. Left: isolation testing using an ohm meter. Right: isolation testing using an RFIT meter.

The engineers have also seen a number of issues with customer practices regarding electrical isolation testing. GPT's experience with users has shown that electrical isolation testing is also undertaken improperly much of the time. Despite this, customers are insistent on the veracity of their measurements, and state that they have been utilising that method for years. Meggers and ohm meters are often used to test isolation. This is not a definitive isolation result as it is testing the resistance of the isolated joint. There have been many instances where customers have tested the isolation of their joint with a Megger or ohm meter prior to a hydrotest with successful results, then performed a hydrotest and tested with a Megger or ohm meter afterward to find that the value is below the necessary 10 MΩ or 20 MΩ value that the customer is using as its minimum limit. If the basics of corrosion are remembered, there are four items needed for corrosion to exist: anode, cathode, electrolyte and metallic path. The elimination of any one of these four mechanisms can largely reduce the potential for corrosion. Isolation products are intended to eliminate the metallic path. By using a radio frequency isolation test (RFIT) meter, it is possible to determine if the metallic path is broken or not by utilising a radio frequency, and is a definitive measure regardless of electrolytes in the system.

GPT's engineers utilise a demonstration unit that displays this effect. It is a small flanged unit that has an isolating kit installed with one of the pipe ends blind flanged. The unit is tested electrically, then filled with water and tested again with a Megger or ohm meter. The result is then a 'failed' isolation joint. However, when it is electrically tested pre and post hydrotesting with the RFIT, a reading is presented showing it is indeed a fully isolated joint. The metallic path is eliminated so this joint would not be prone to corrosion.
